PHOTOGRAPHIC INTELLIGENCE REPORT

ASSESSMENT OF BOMB DAMAGE

ALONG THE HANOI -

VINH RAIL LINE

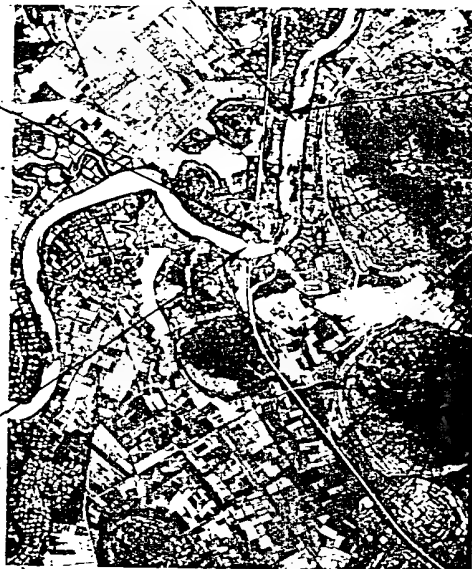
PHOTO # 3

BRIDGE U/C

TEMPORARY
BY-PASS LINE

POSSIBLE BY-PASS

RAIL LINE U/C

DROPPED SPAN

QUI VINH RAILROAD BRIDGE

12. Qui Vinh rail bridge 19 15N - 105 41E has the two northernmost spans dropped. The northern approach was heavily damaged. There was no evidence of any attempt to repair the rail line; however, a possible temporary rail bridge is being constructed immediately east of the destroyed bridge and a possible by-pass line is under construction in this area. (See Photo No. 3)
